Manhole Inspection Summary

Manhole # S13AA1004MH

Insp Date: **1/26/09 9:41 AM**

Location Address: **4007 WABASH AVE**

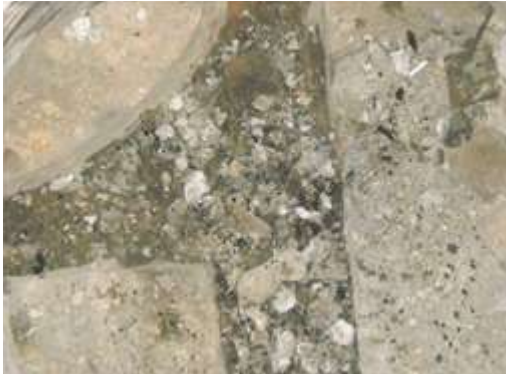
Defect 4

Condition: ☐ Sound ☐ Cracked ☐ Root Intrusion ☐ Deteriorated ☐ Leaks ☒ **Debris**

DEBRIS IN CHANNEL

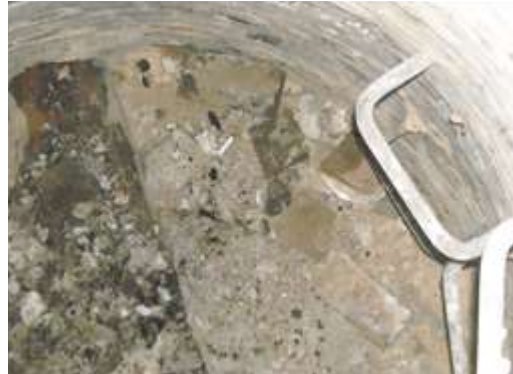
Defect 3

DEBRIS ON BENCH

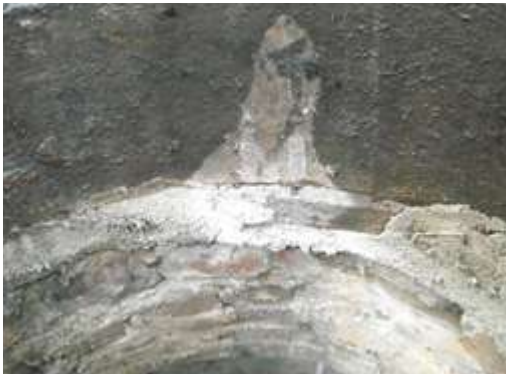
Defect 2

Infiltration: ☐ None ☒ **Joint** ☐ Cracks ☐ Mortar ☐ Roots ☐ Wall

EVIDENCE OF PRIOR INFILTRATION
THROUGH CHIMNEY/FRAME JOINT

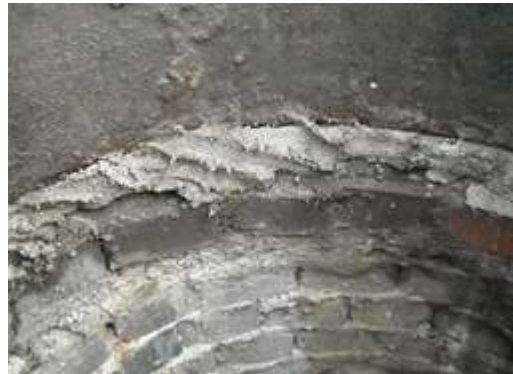
Defect 1

CHIMNEY ADJUSTMENT 4" PARGED

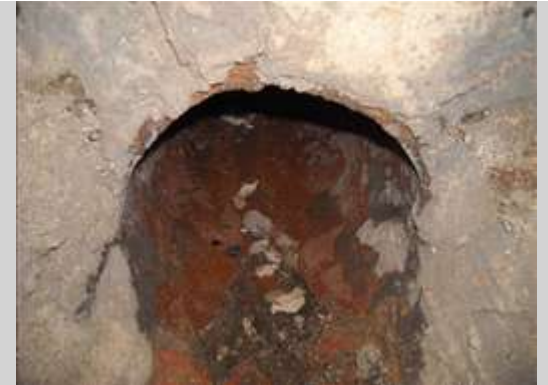
12 O'Clock Outflow

Pipe Height: **8.4** (in.) Rod and Bar (Angled)
Pipe Material: **Clay** ☐ Pipe Lined
Invert Depth: **9.25** (ft.) Flow Characteristics: **None**
Deposits: ☐ None ☐ Mud ☐ Sludge ☒ **Debris** ☐ Grease
Silt Depth: **2** (in.) Deposits Extent: **Light**
Infiltration: **None** Pipe Seal Cond: **Sound**

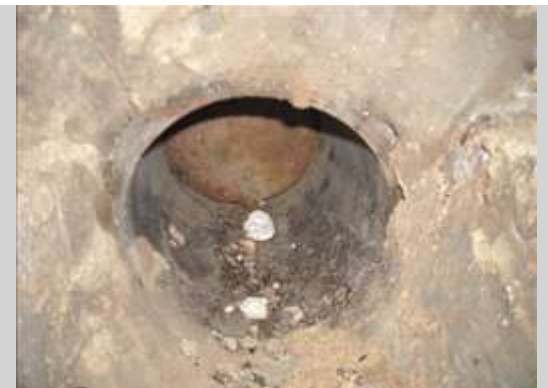
6 O'Clock Inflow

STUB CONNECTION

Connects To: **Stub connection / abandoned**

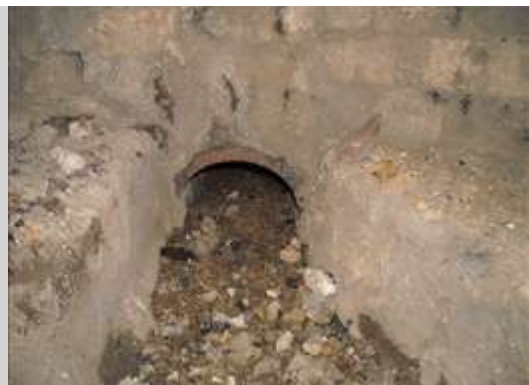
9 O'Clock Inflow

NOTE THE DEBRIS IN THE PIPE BUT
BELIEVE ABANDONED
